DOT/FAA/AR-96/21

Composite Failure Analysis Handbook Update 1

August 1997

Final Report

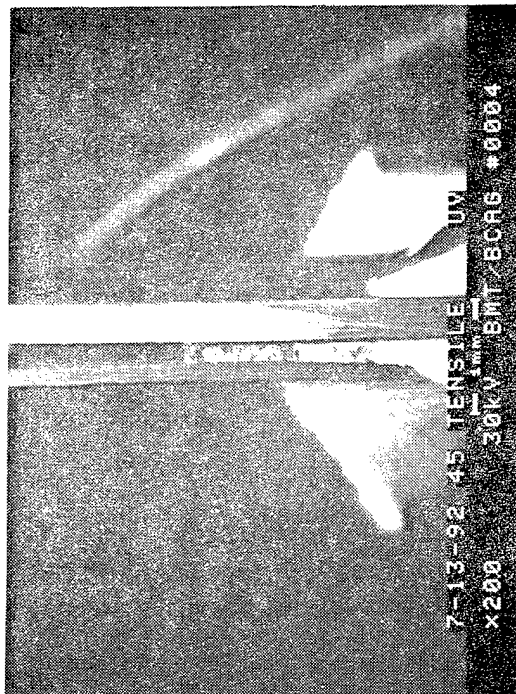
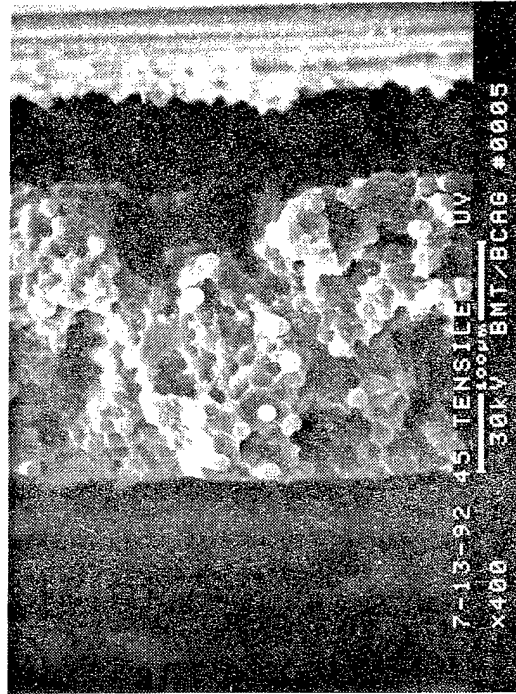
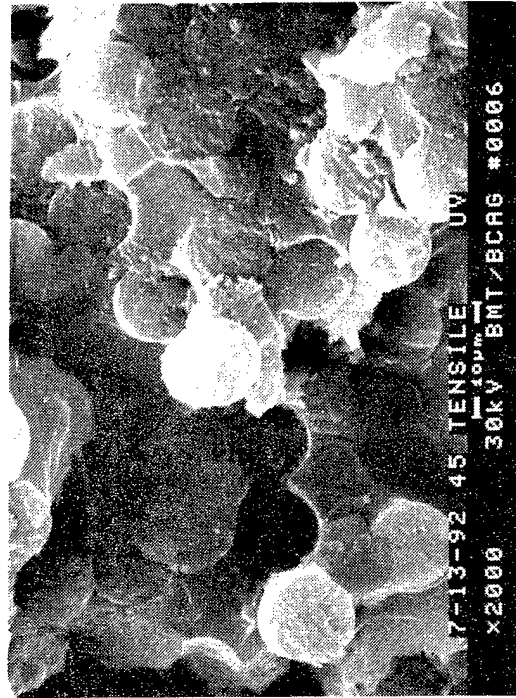
Figure 3.1-18. SEM Fractographs of a 3501-6/AS4 \pm 45 Tensile Specimen Exposed to UV Radiation, Translaminar Surface

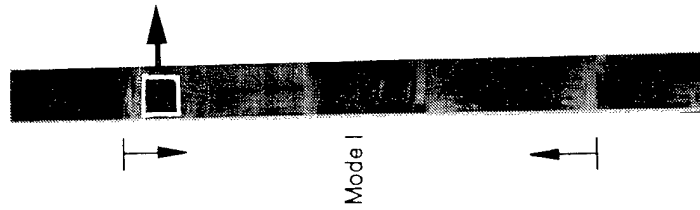
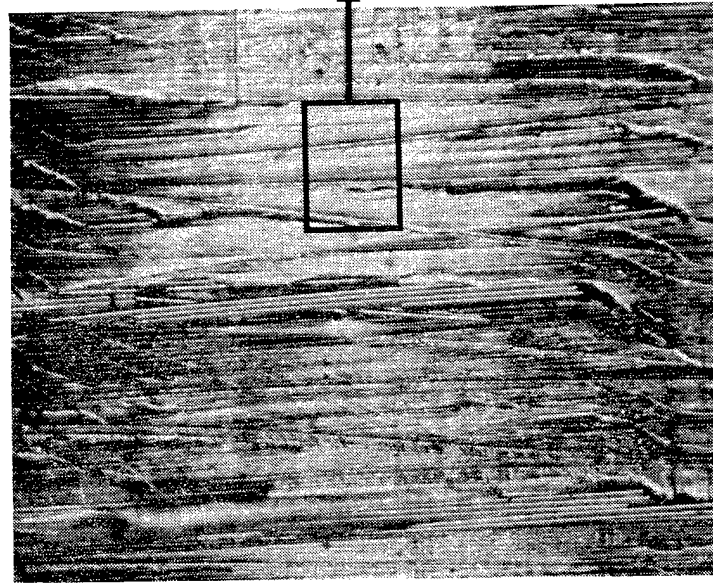
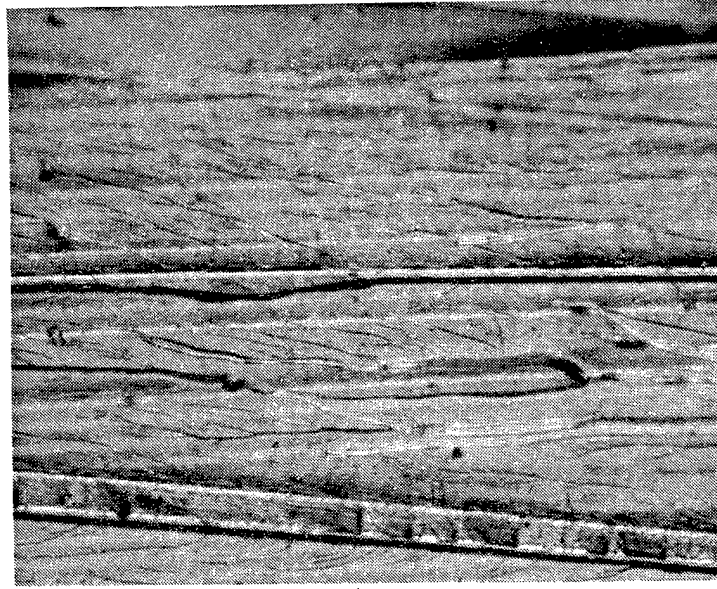
Figure 3.1-19. Optical Fractographs of 3501-6/AS4 Interlaminar Mode I (Tension), Specimen Thermally Cycled Prior to Loading

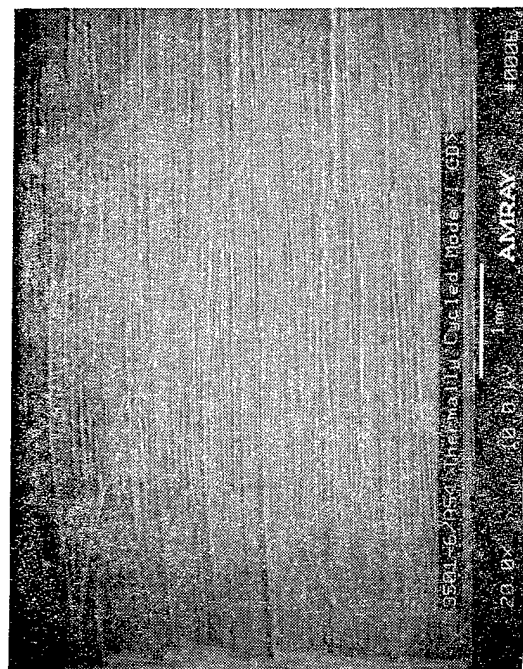
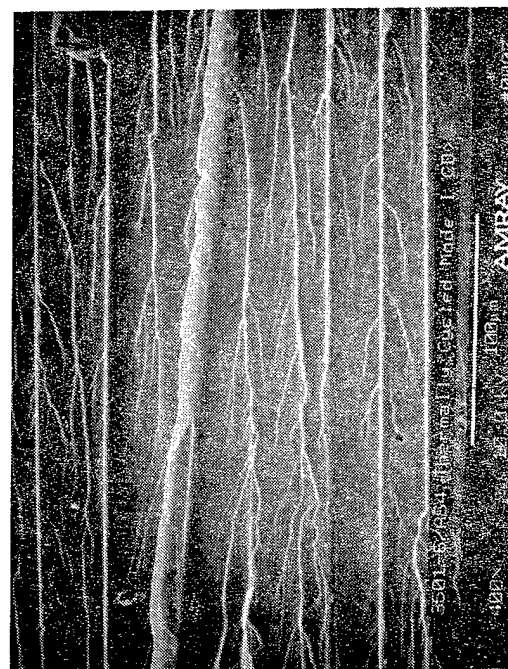
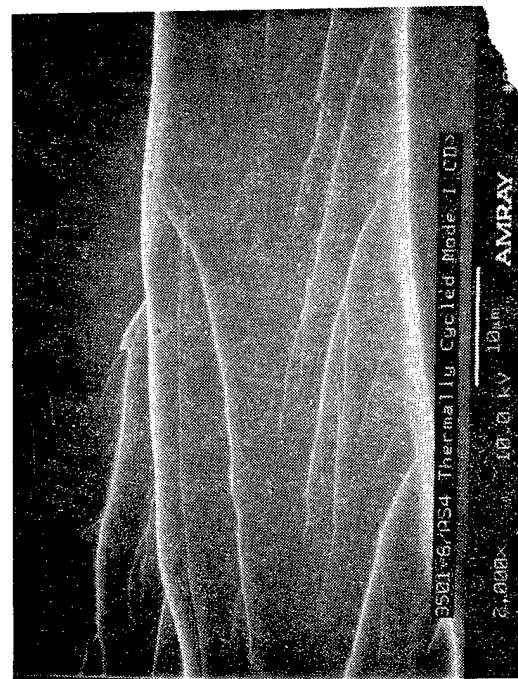
Figure 3.1-20. SEM Fractographs of a 3501-6/AS4 Interlaminar Mode I Tension Fracture Surface, Thermally Cycled

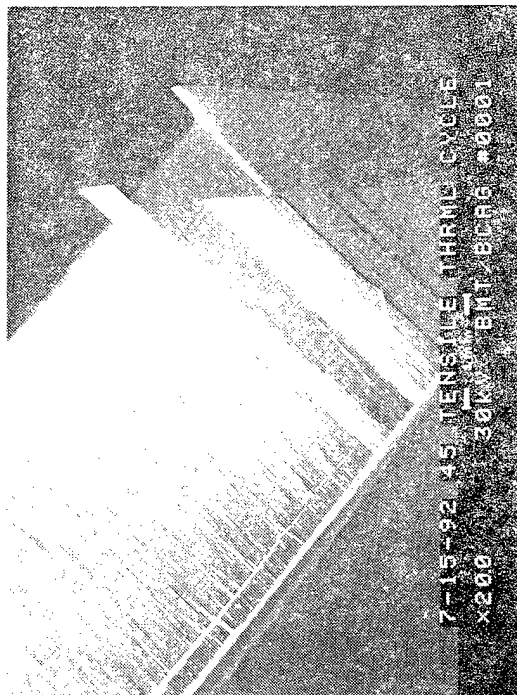
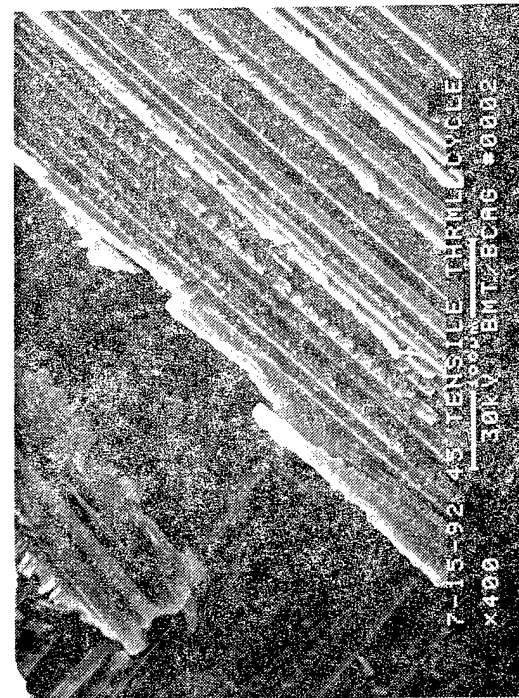
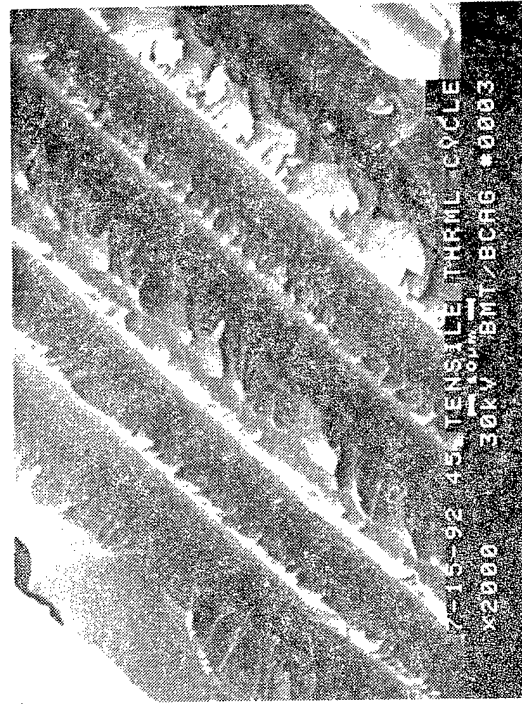
Figure 3.1-21. SEM Fractographs of a 3501-6/AS4 \pm 45 Tensile Specimen Thermally Cycled, Interlaminar Surface

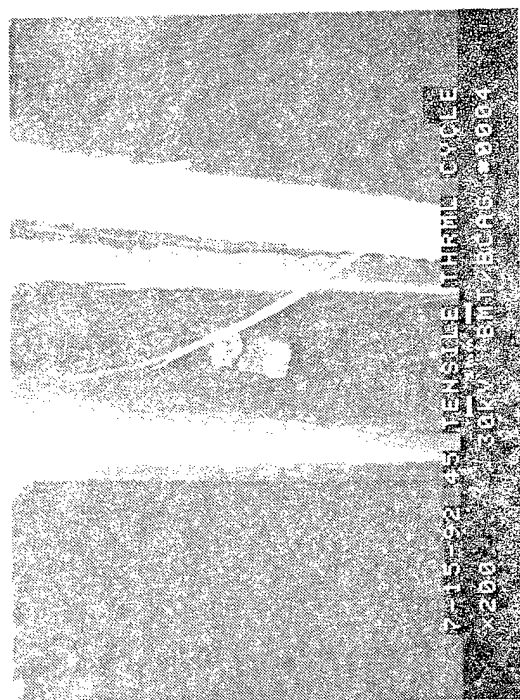
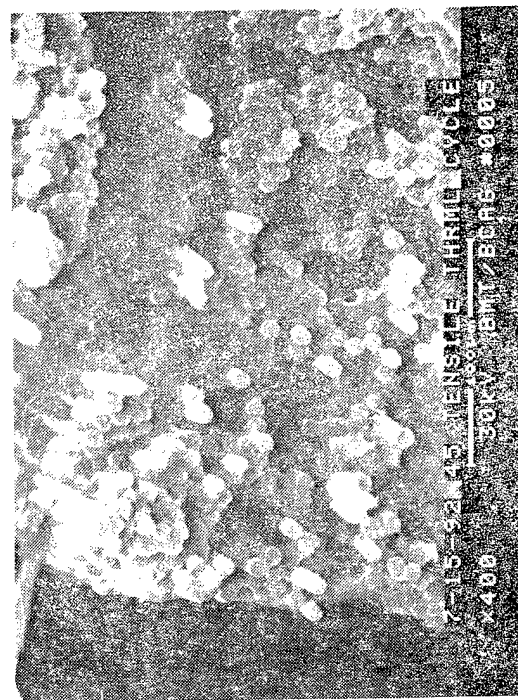
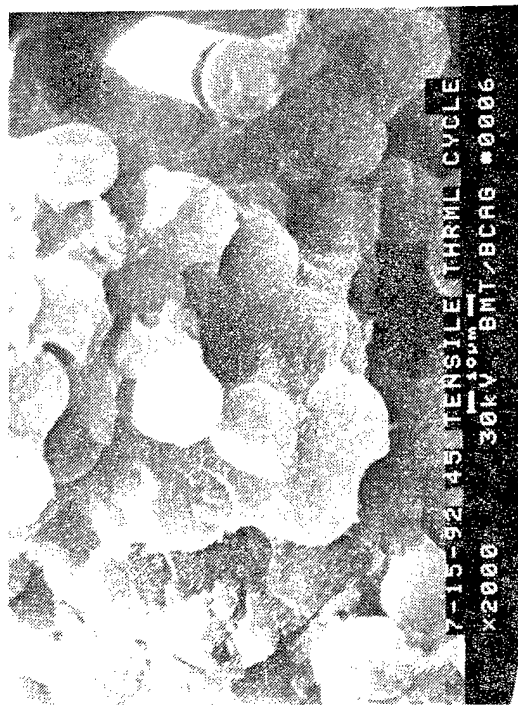
Figure 3.1-22. SEM Fractographs of a 3501-6/AS4 \pm 45 Tensile Specimen Thermally Cycled, Translaminar Surface

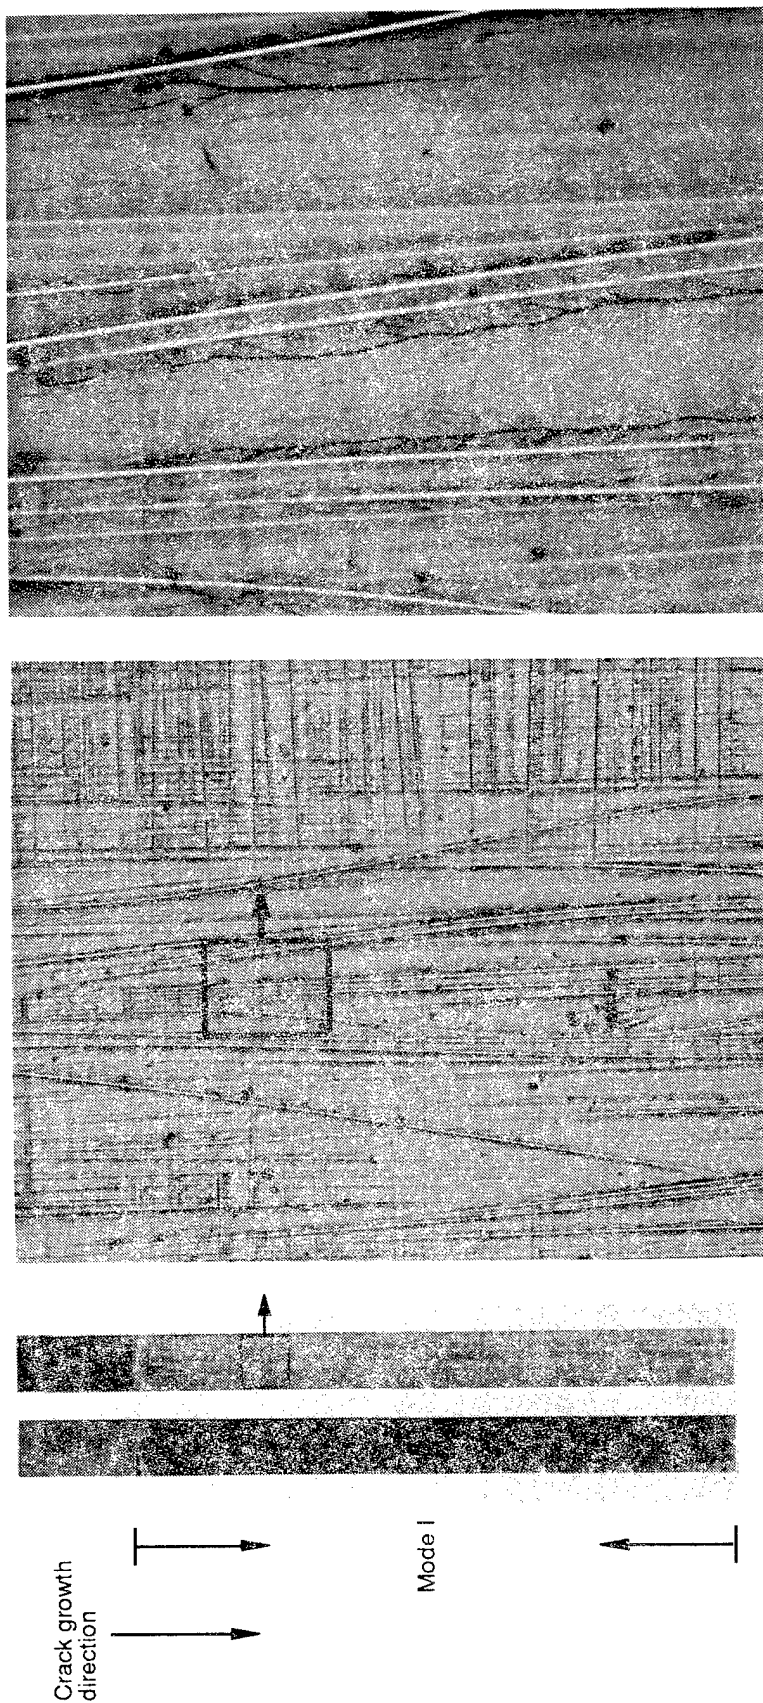
Figure 3.1-23. Optical Fractography of 3501-6/AS4 Interlaminar Mode I Tension Specimen, Moisture/Dryout Cycled

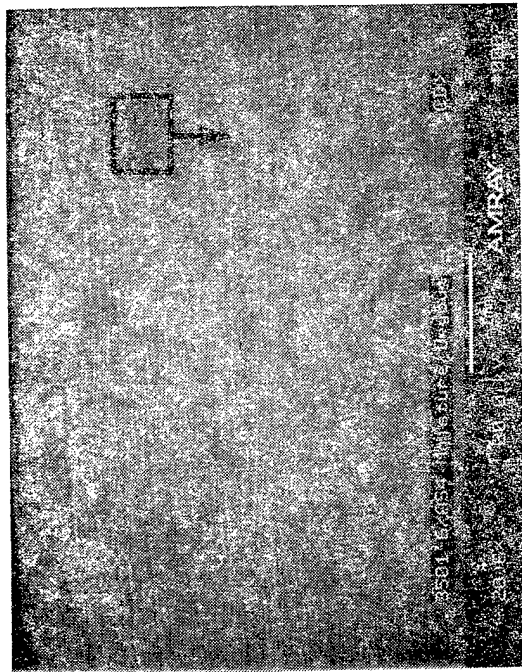
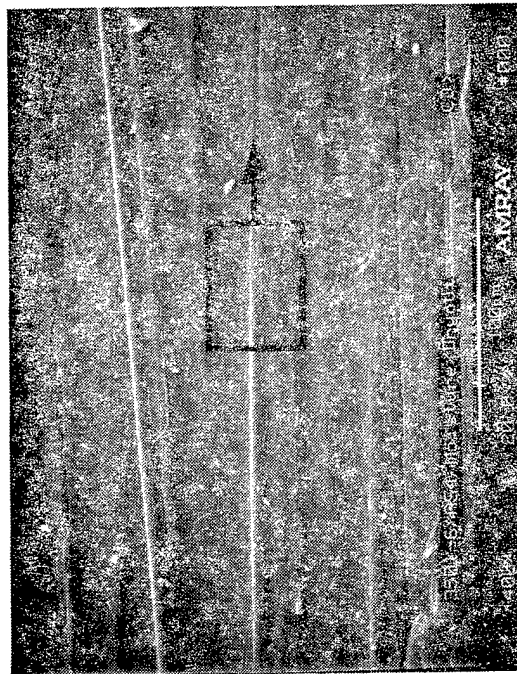
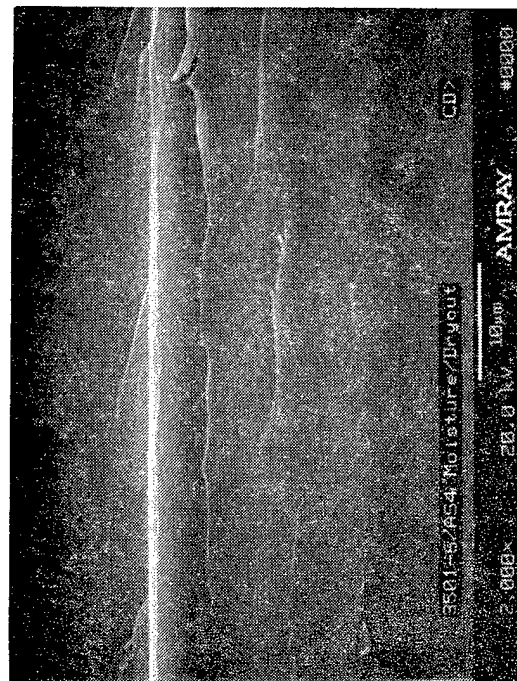
Figure 3.1-24. SEM Fractographs of a 3501-6/AS4 Interlaminar Mode I Tensile Fracture Surface Tested After Moisture/Dryout Cycling

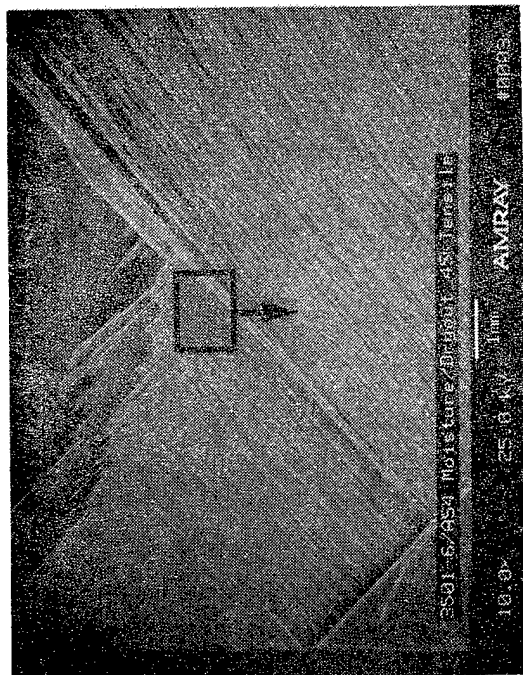
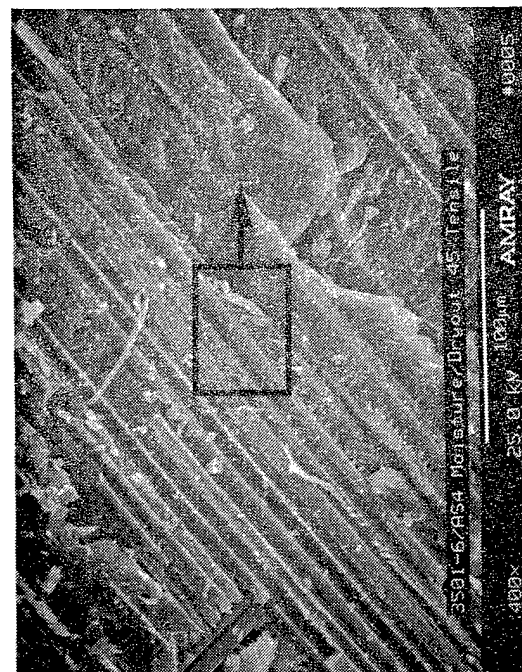
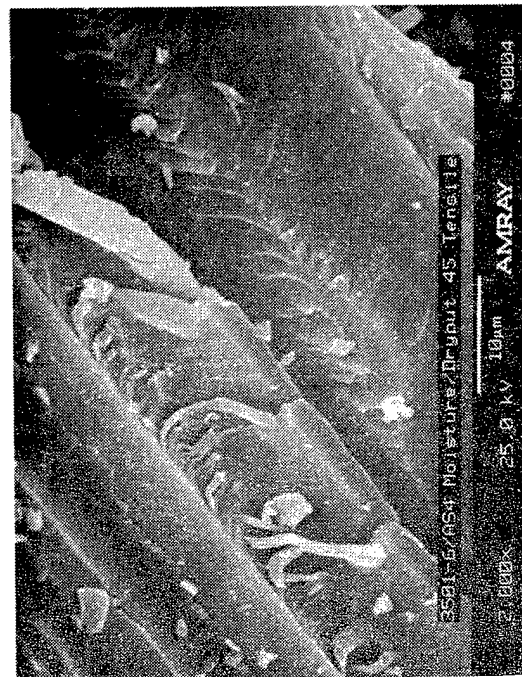
Figure 3.1-25. SEM Fractographs of a 3501-6/AS4 $\pm 45^\circ$ Tensile Specimen Tested After Moisture/Dryout Cycling, Interlaminar Surface

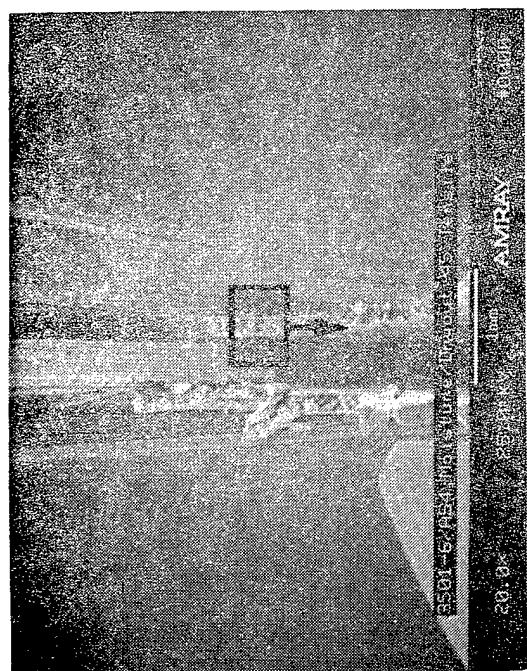
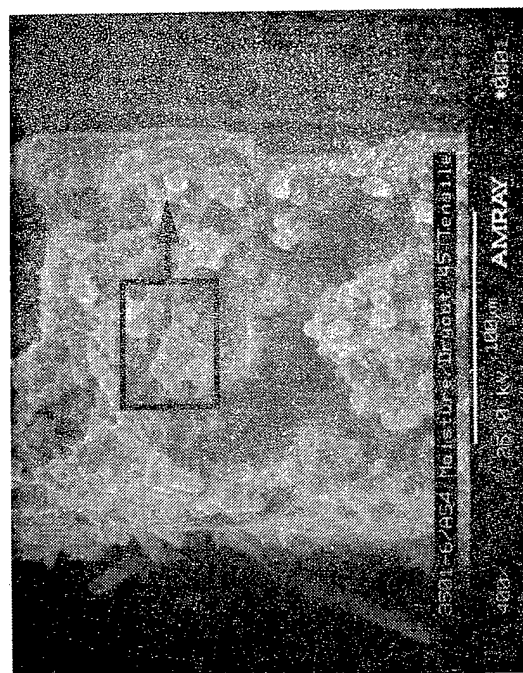
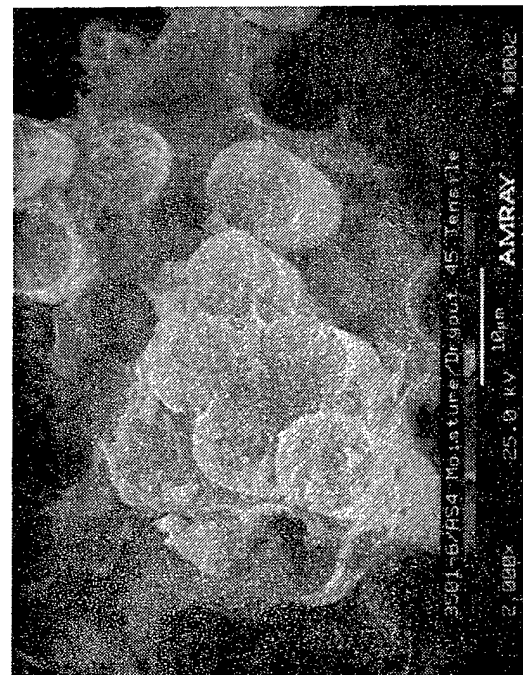
Figure 3.1-26. SEM Fractographs of a 3501-6/AS4 $\pm 45^\circ$ Tensile Specimen Tested After Moisture/Dryout Cycling, Translaminar Surface

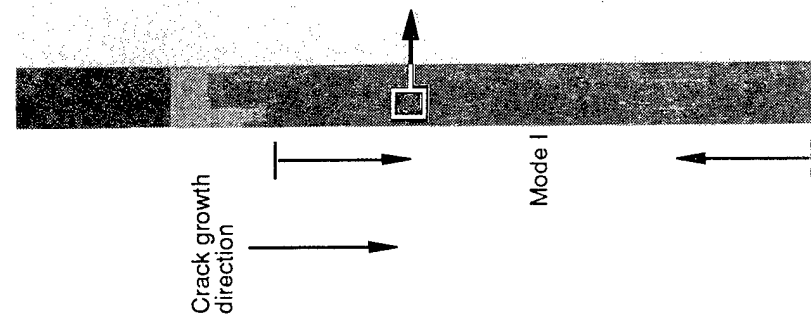
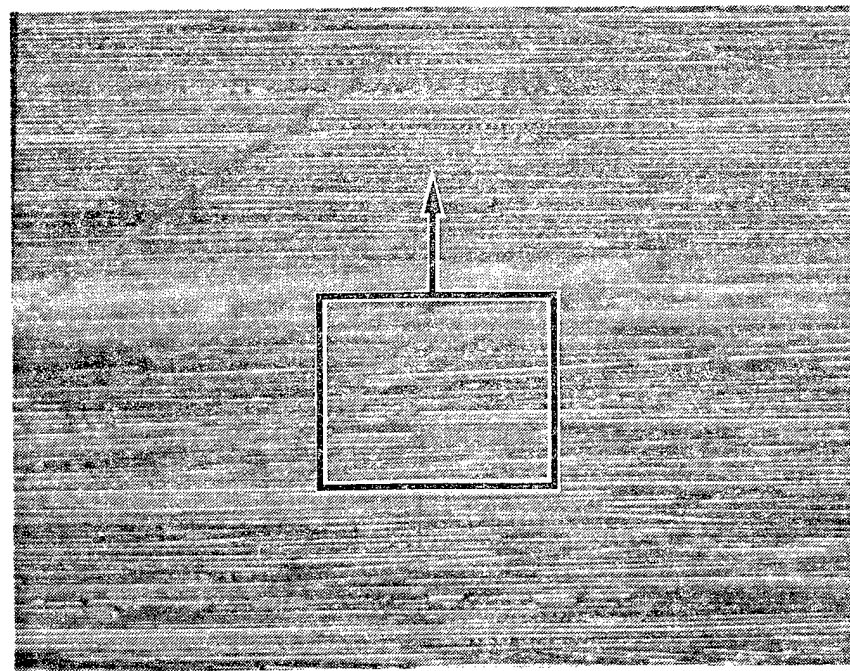
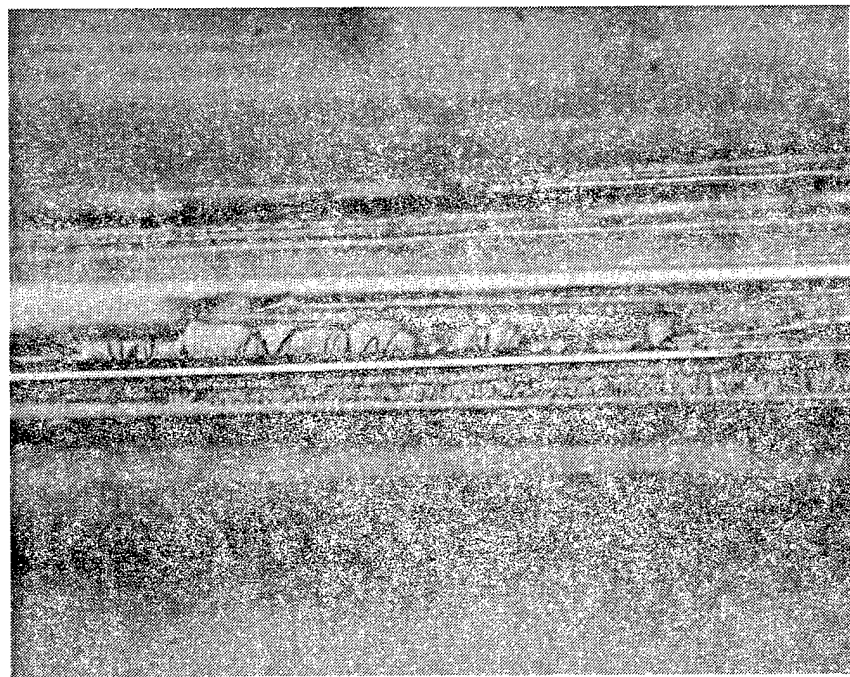
Figure 3.2-1. Optical Fractography of KII/AS4 Interlaminar Mode I Tension Specimen Tested at RT/Dry

The fracture morphology of the specimens exhibited similar features as those of the PEEK material system, which is a true thermoplastic. On a macroscopic scale, numerous loose fibers were on the surface due to fiber pull-out. Microscopically, these features include the slow ductile peeling of the matrix craze filaments, which produce a limited river pattern and some cusps, which are generally associated with mode II (shear) loading (Figures 3.2-1 and 3.2-2).

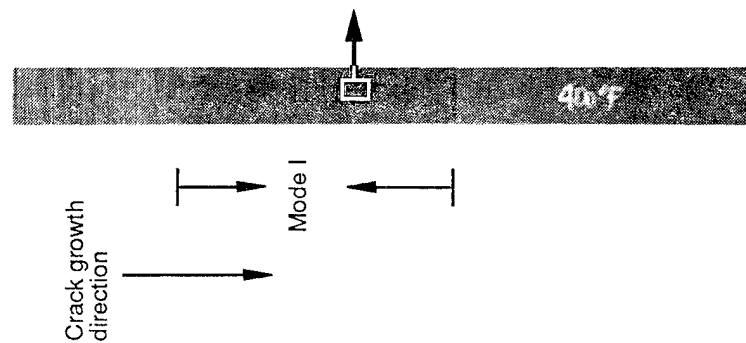
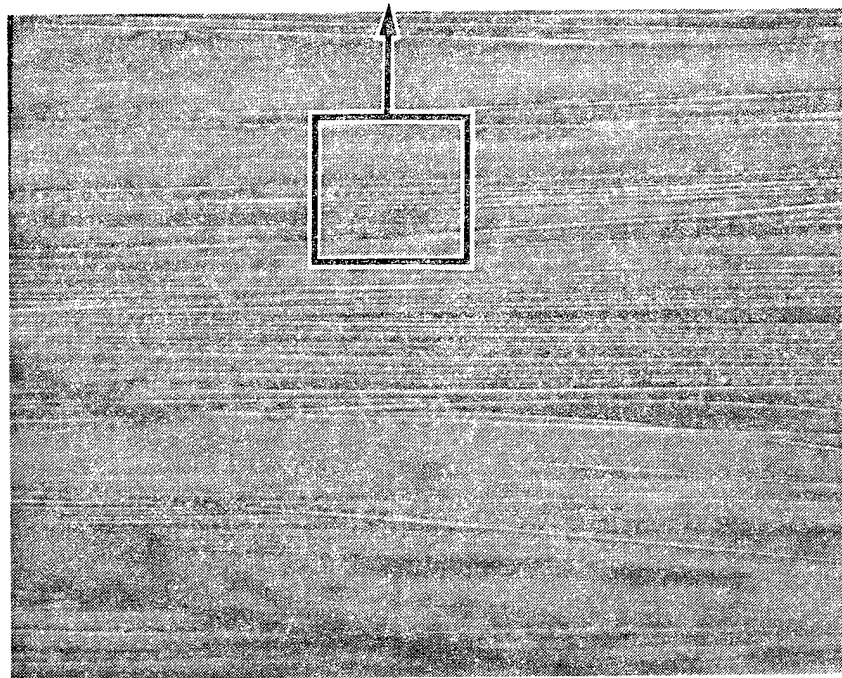
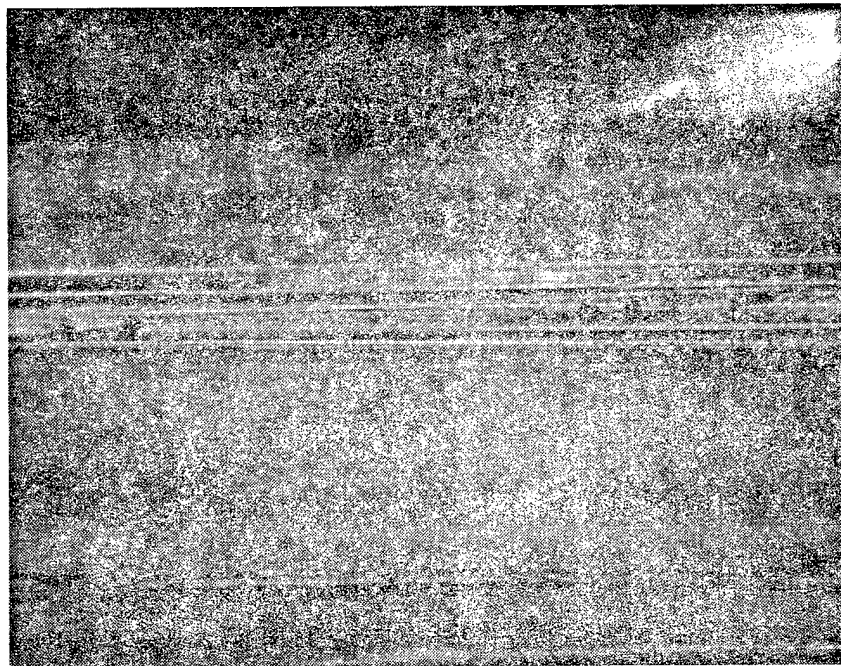
Figure 3.2-3. Optical Fractography of KIII/AS4 Interlaminar Mode I Tension Specimen Tested at 400° F/Dry

This fracture surface was generally similar to the RT surface but with minor differences such as fibers pulled out from the surface and slightly larger matrix craze filaments (Figures 3.2-3 and 3.2-4).

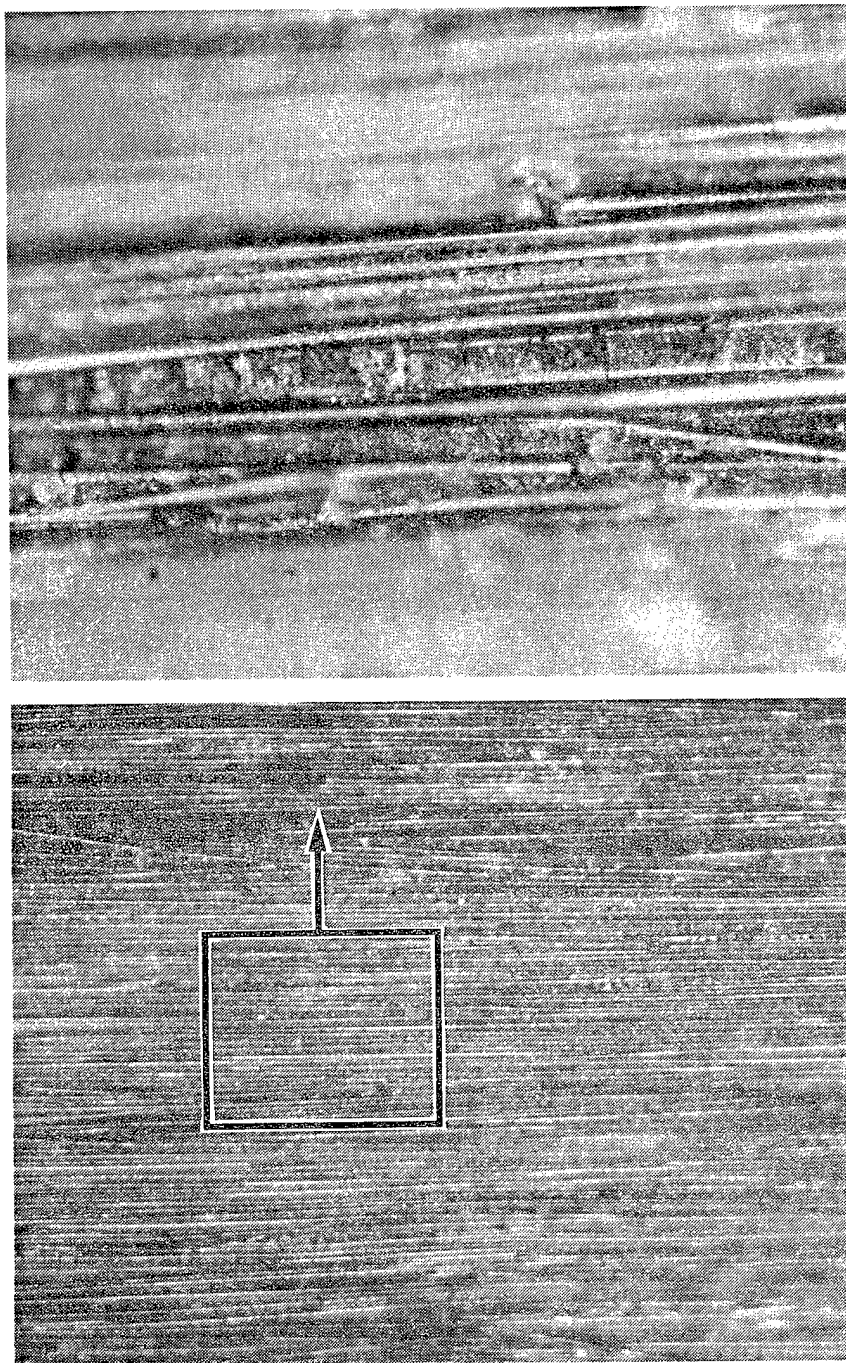
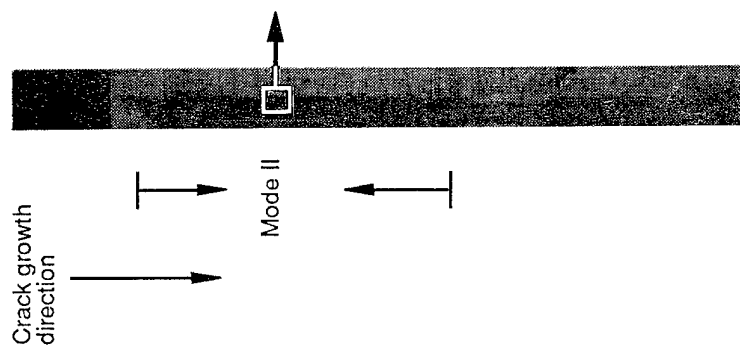
Figure 3.2-5. Optical Fractography of KIIII/AS4 Interlaminar Mode II Shear Specimen Tested at RT/Dry

As with the mode I (tensile) case, the mode II (shear) surface morphology exhibited features similar to those of the PEEK specimens, except that there were no loose fibers on the surface. This morphology was also similar to the KIII/AS4 mode I surface, making it difficult to determine the loading condition (Figures 3.2-5 and 3.2-6).

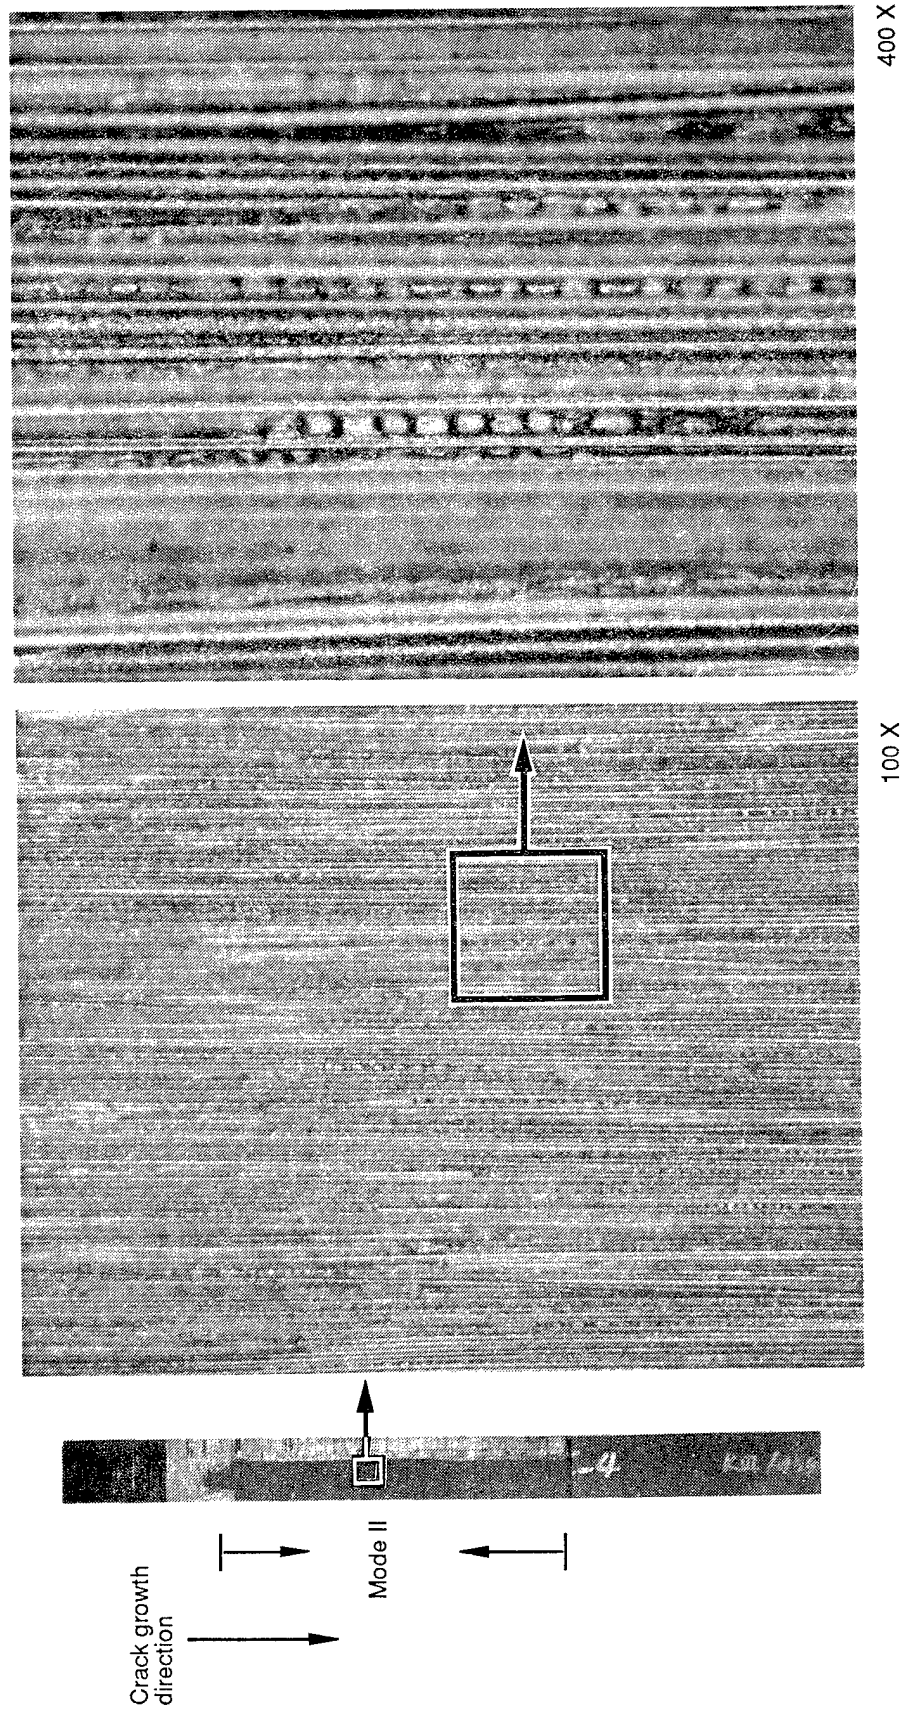
Figure 3.2-7. Optical Fractography of KIII//AS4 Interlaminar Mode II Shear Specimen Tested at 400° F/Dry

There were no significant differences between the fracture morphology of the RT and the elevated temperature test specimens as shown in Figures 3.2-7 and 3.2-8.

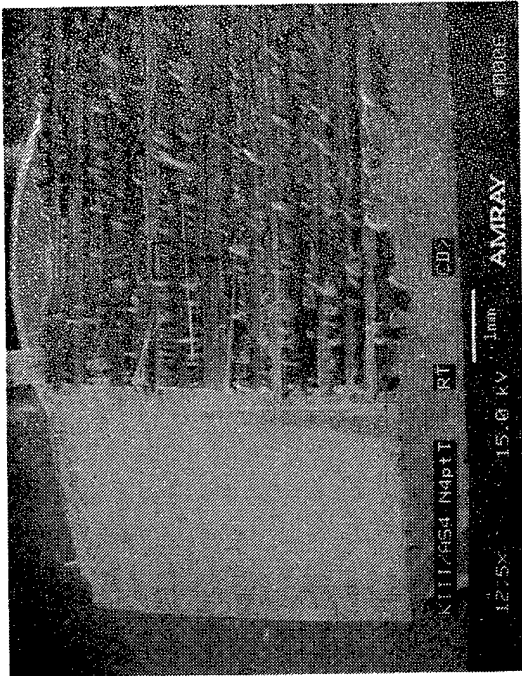
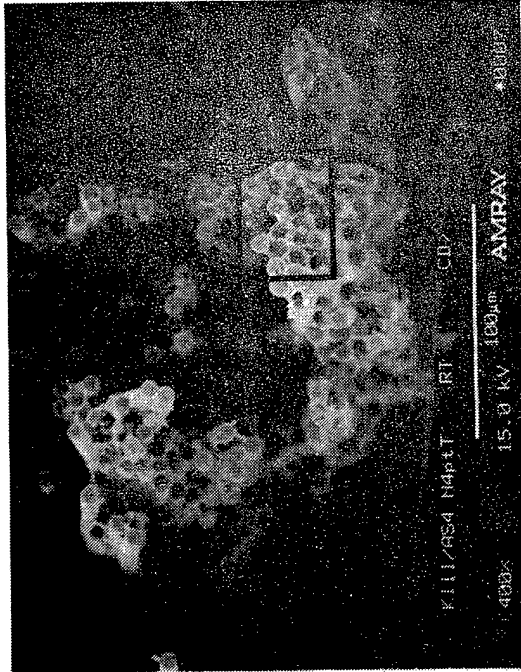
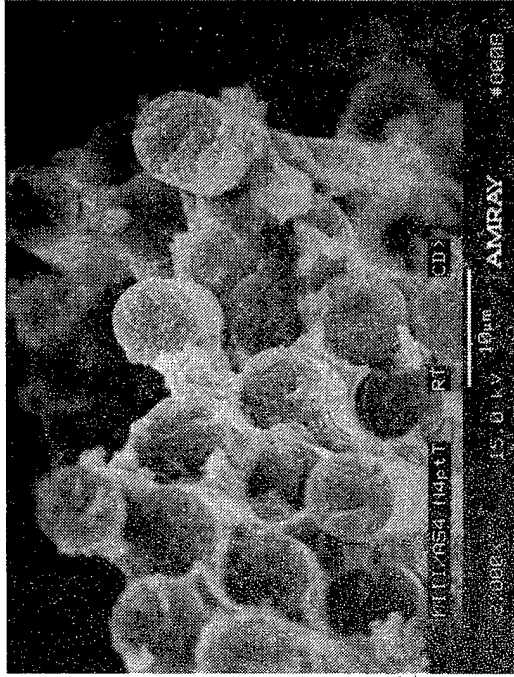
Figure 3.2-9. SEM Fractographs of a KIII/AS4 N4ptT Specimen, Transverse Fracture Surface, Room Temperature

The overall appearance of the room temperature fracture morphology was typical of a notched four-point tensile specimen, exhibiting a very jagged surface. The fracture origins on the fiber ends were easily visible and generally indicated the overall mechanically induced crack direction (Figure 3.2-9). The interlaminar surfaces (Figure 3.2-10) were identical to the mode I fracture morphology as described above.

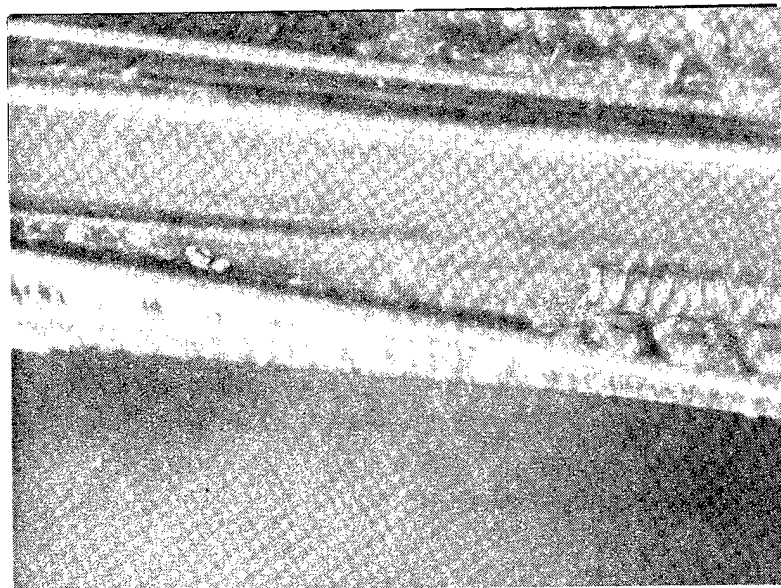
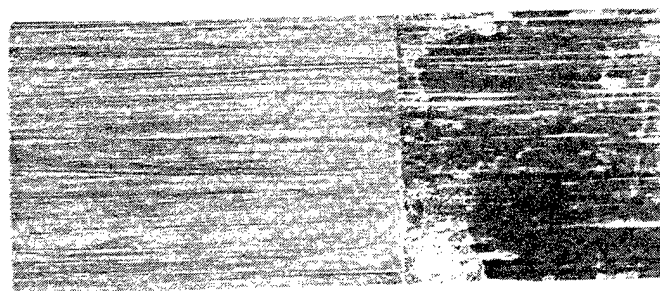
Figure 3.2-11. Optical Fractographs of a KIII/AS4 Interlaminar Mode I (Tensile) Fatigue Fracture Surface, RT

Both the RT (Figures 3.2-11 & 3.2-12) and the 350°F tested specimens (Figures 3.2-13 & 3.2-14) exhibited similar fracture features which appeared to resemble a mode II (shear) morphology. The resin material between the fibers contained hackles which indicated the overall crack growth orientation. No rivermarks or other distinctive mode I features were observed.

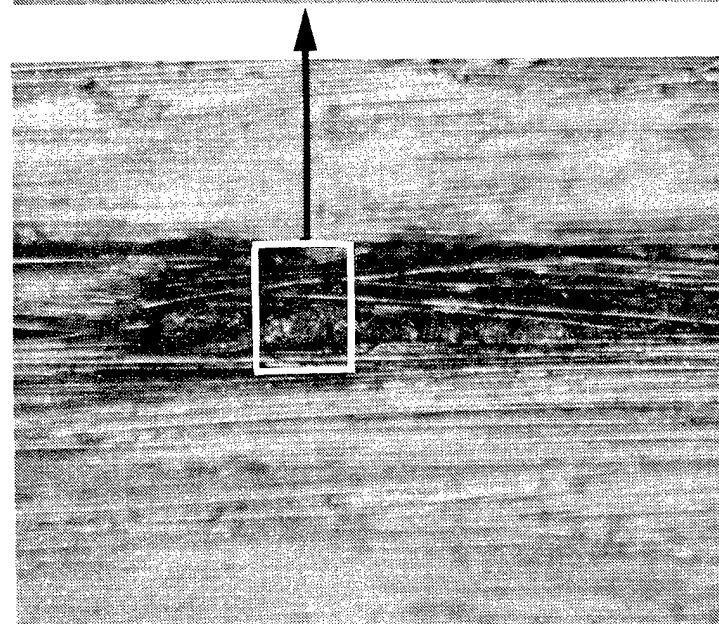
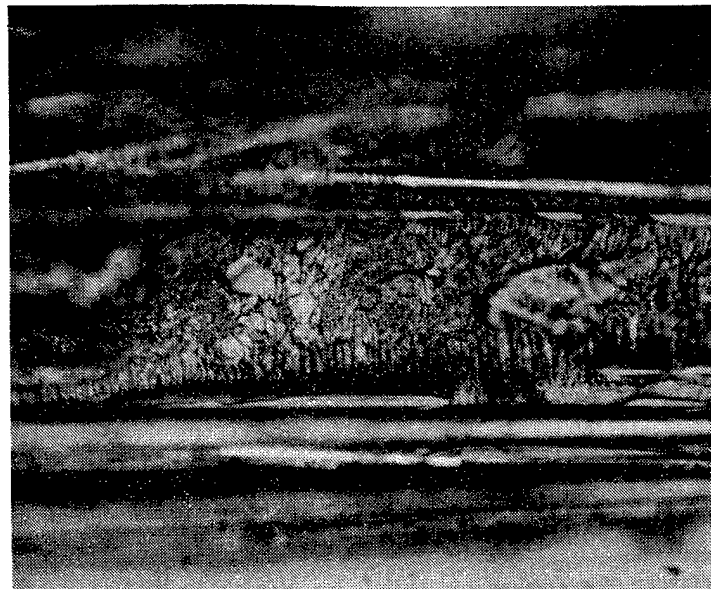
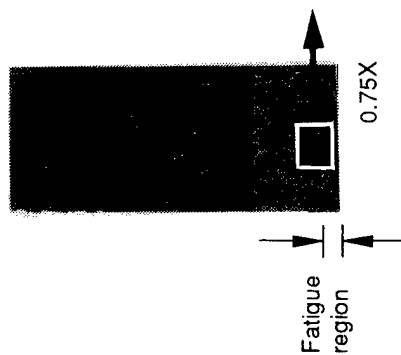
Figure 3.2-15. Optical Fractographs of KIII/AS4 Interlaminar Mode II (Shear) Fatigue, Room Temperature, High Stress

Examination of the fracture surfaces did not reveal any definite indications of fatigue, except for a feature that may be related to the cyclic loading. This feature appeared to be typical of a mode II hackle. However, when observed at high magnification the feature appears to be wider and thinner than similar hackles on statically loaded specimens. This feature was observed both on the RT specimen (Figures 3.2-15 and 3.2-16) and the 350°F tested specimens (Figures 3.2-17 and 3.2-18).

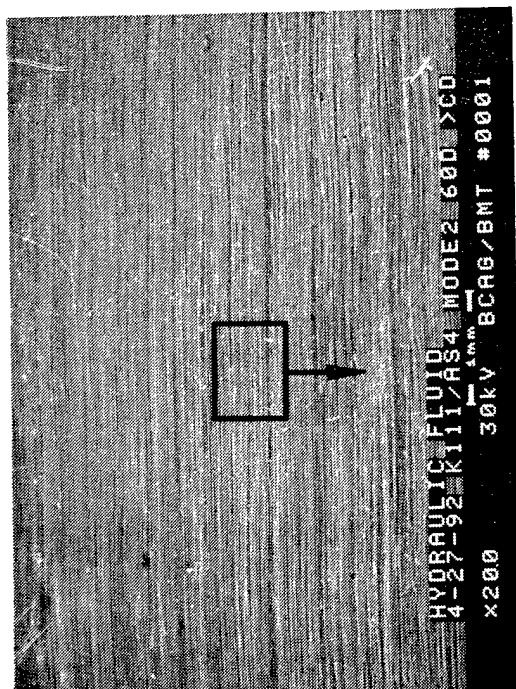
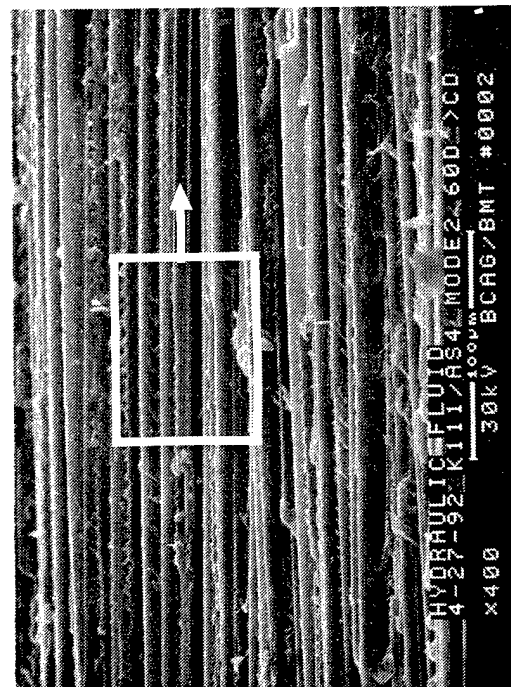
Figure 3.2-19. SEM Fractographs of a K111/AS4 Interlaminar Mode II Shear Fracture Surface Exposed to Hydraulic Fluid for 7 Days

Examination of the mode II surfaces (Figure 3.2-19 through Figure 3.2-25) exposed to the various environments revealed that the hydraulic fluid (Figure 3.2-19) and JP4 jet fuel (Figure 3.2-20) slightly degraded the fracture features. The fibers appeared to be "cleaner" when compared to the control specimens. However, this did not alter the surface morphology enough to prevent identification of the mode II fracture features, such as the cusp and matrix filaments.

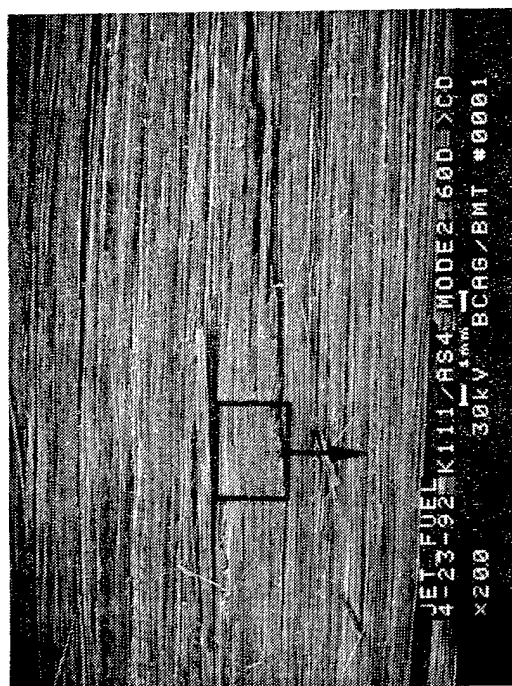
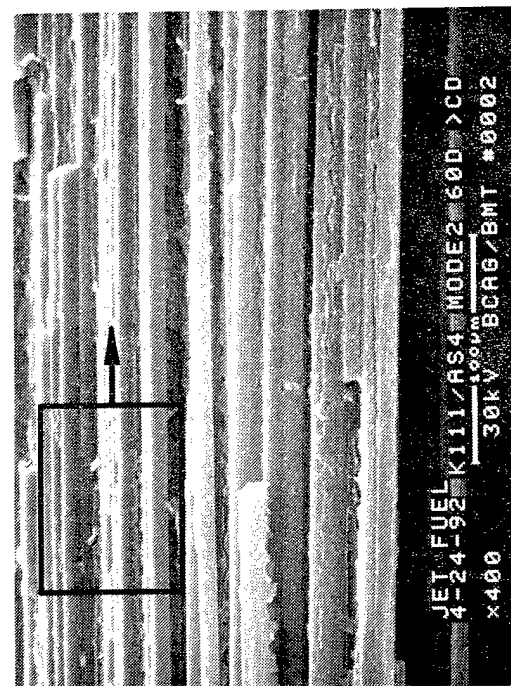
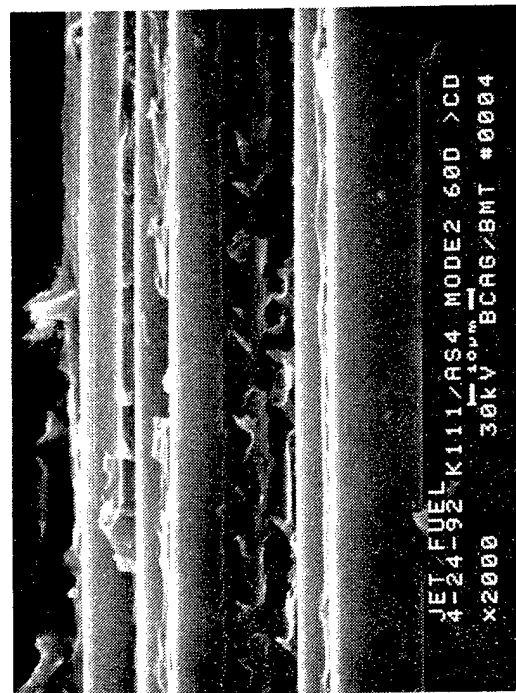
Figure 3.2-20. SEM Fractographs of a K111/AS4 Interlaminar Mode II Shear Fracture Surface Exposed to JP4 Jet Fuel for 7 Days

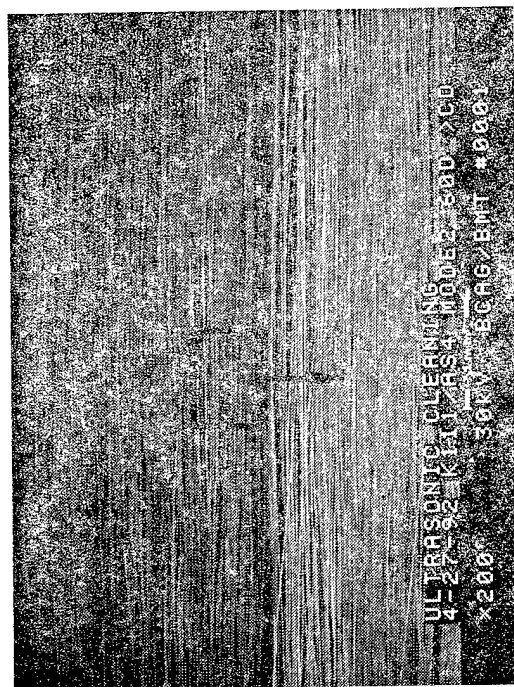
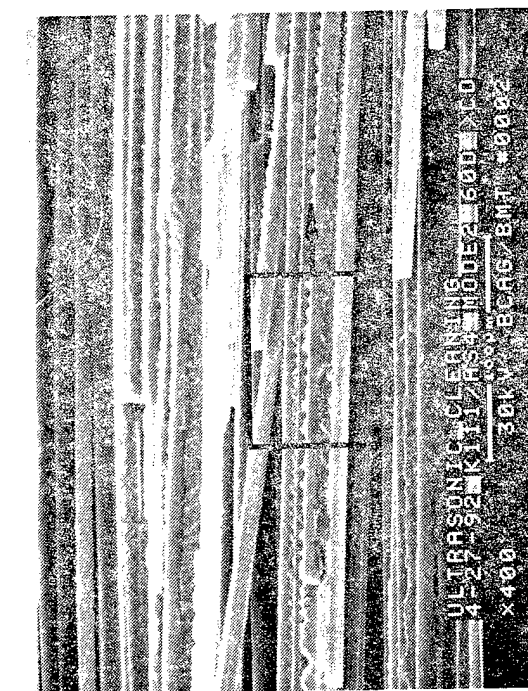
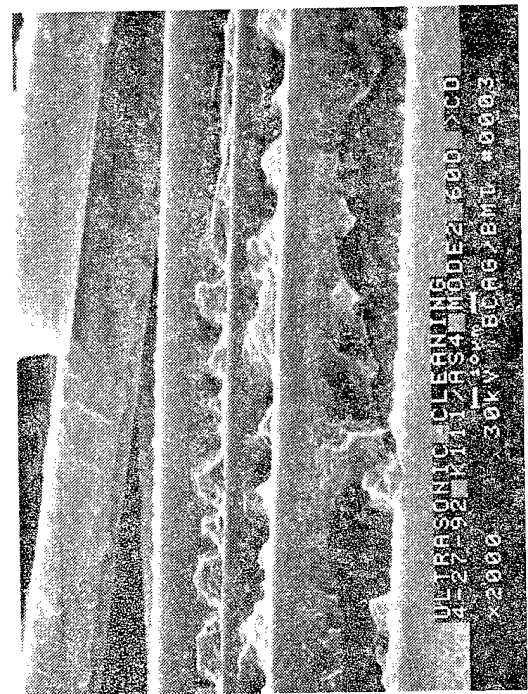
Figure 3.2-21. SEM Fractographs of a K111/AS4 Interlaminar Mode II Shear Fracture Surface Exposed to Ultrasonic Agitation in Distilled Water for 24 Hours
2405.01 9-5576 D1ai
